TEST REPORT

1994-CPR-RP2772

**Balcony door, sliding folding, with three casements,
trade name
“FW77+”
(see description)**

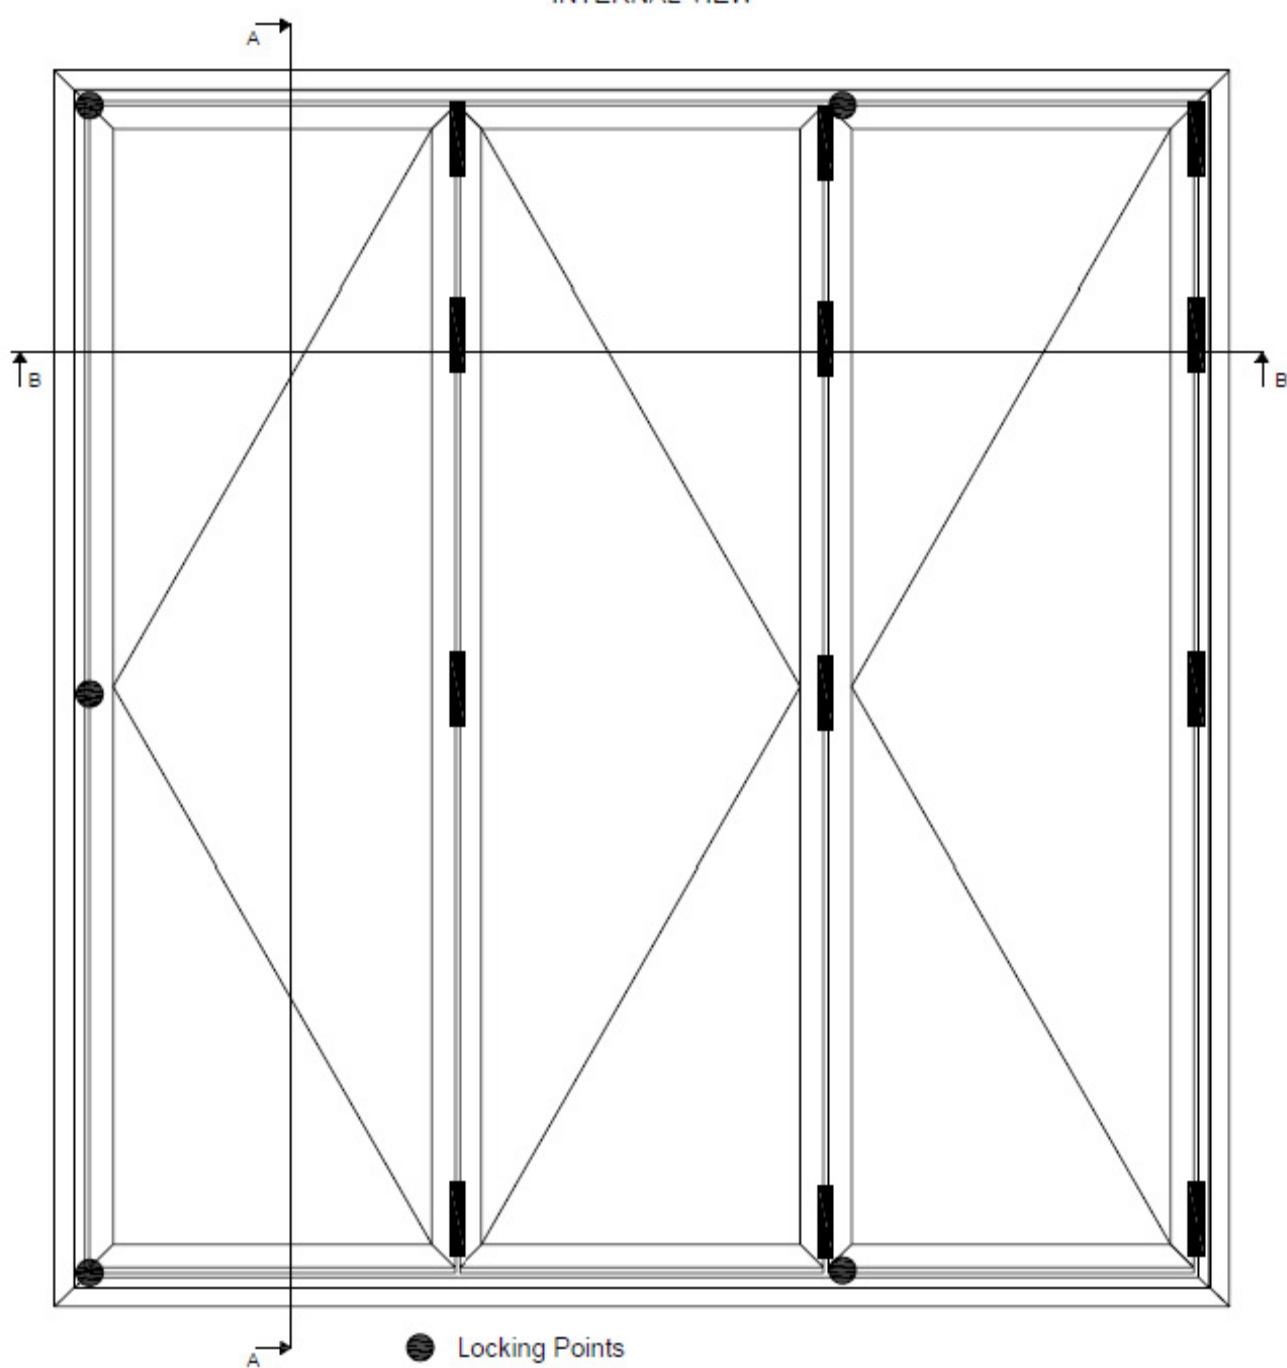
Fig. 1. Front view of the received and tested sample, positioning scheme of locking device: front view

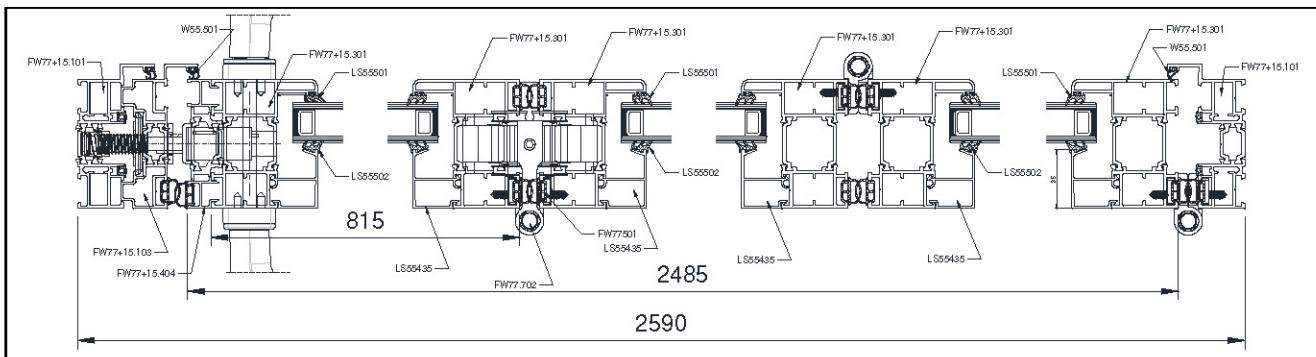
Fig. 2. Horizontal section BB of the tested sample
(declared nominal dimensions in mm)

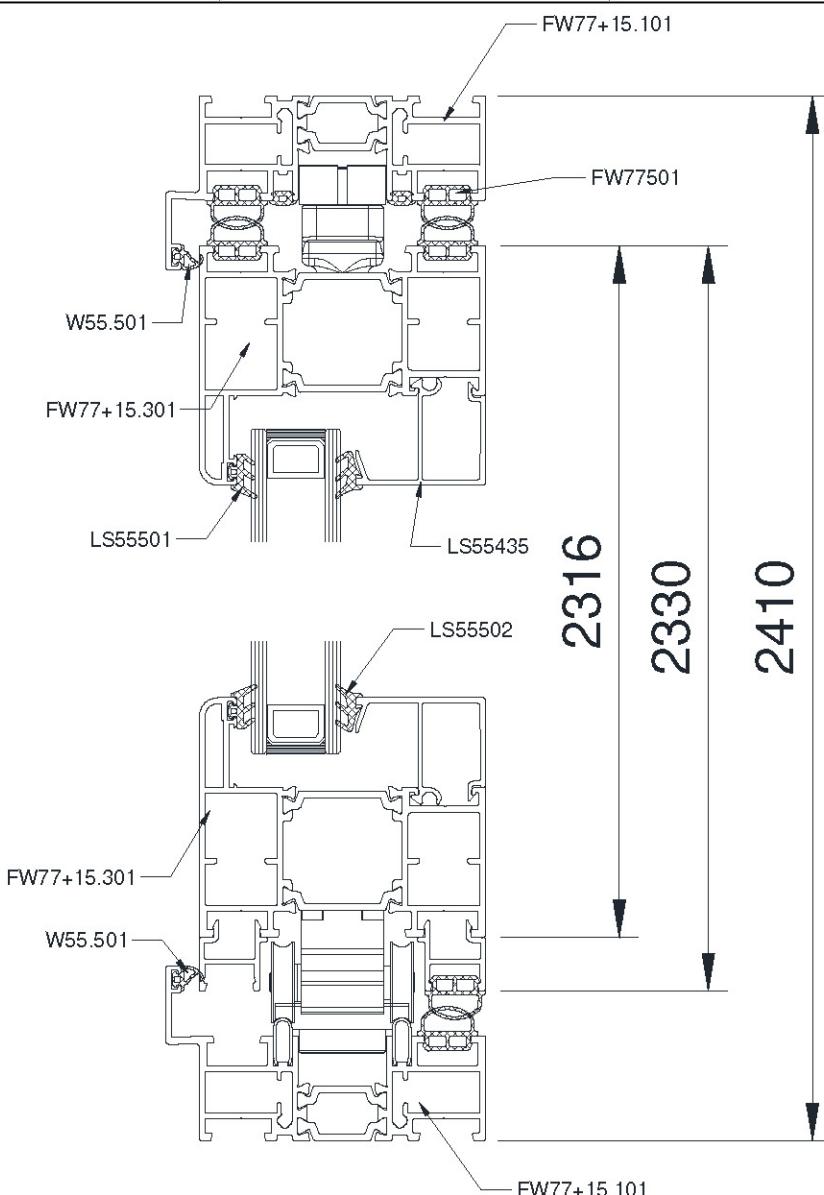
Fig. 3. Vertical section AA of the tested sample
(declared nominal dimensions in mm)

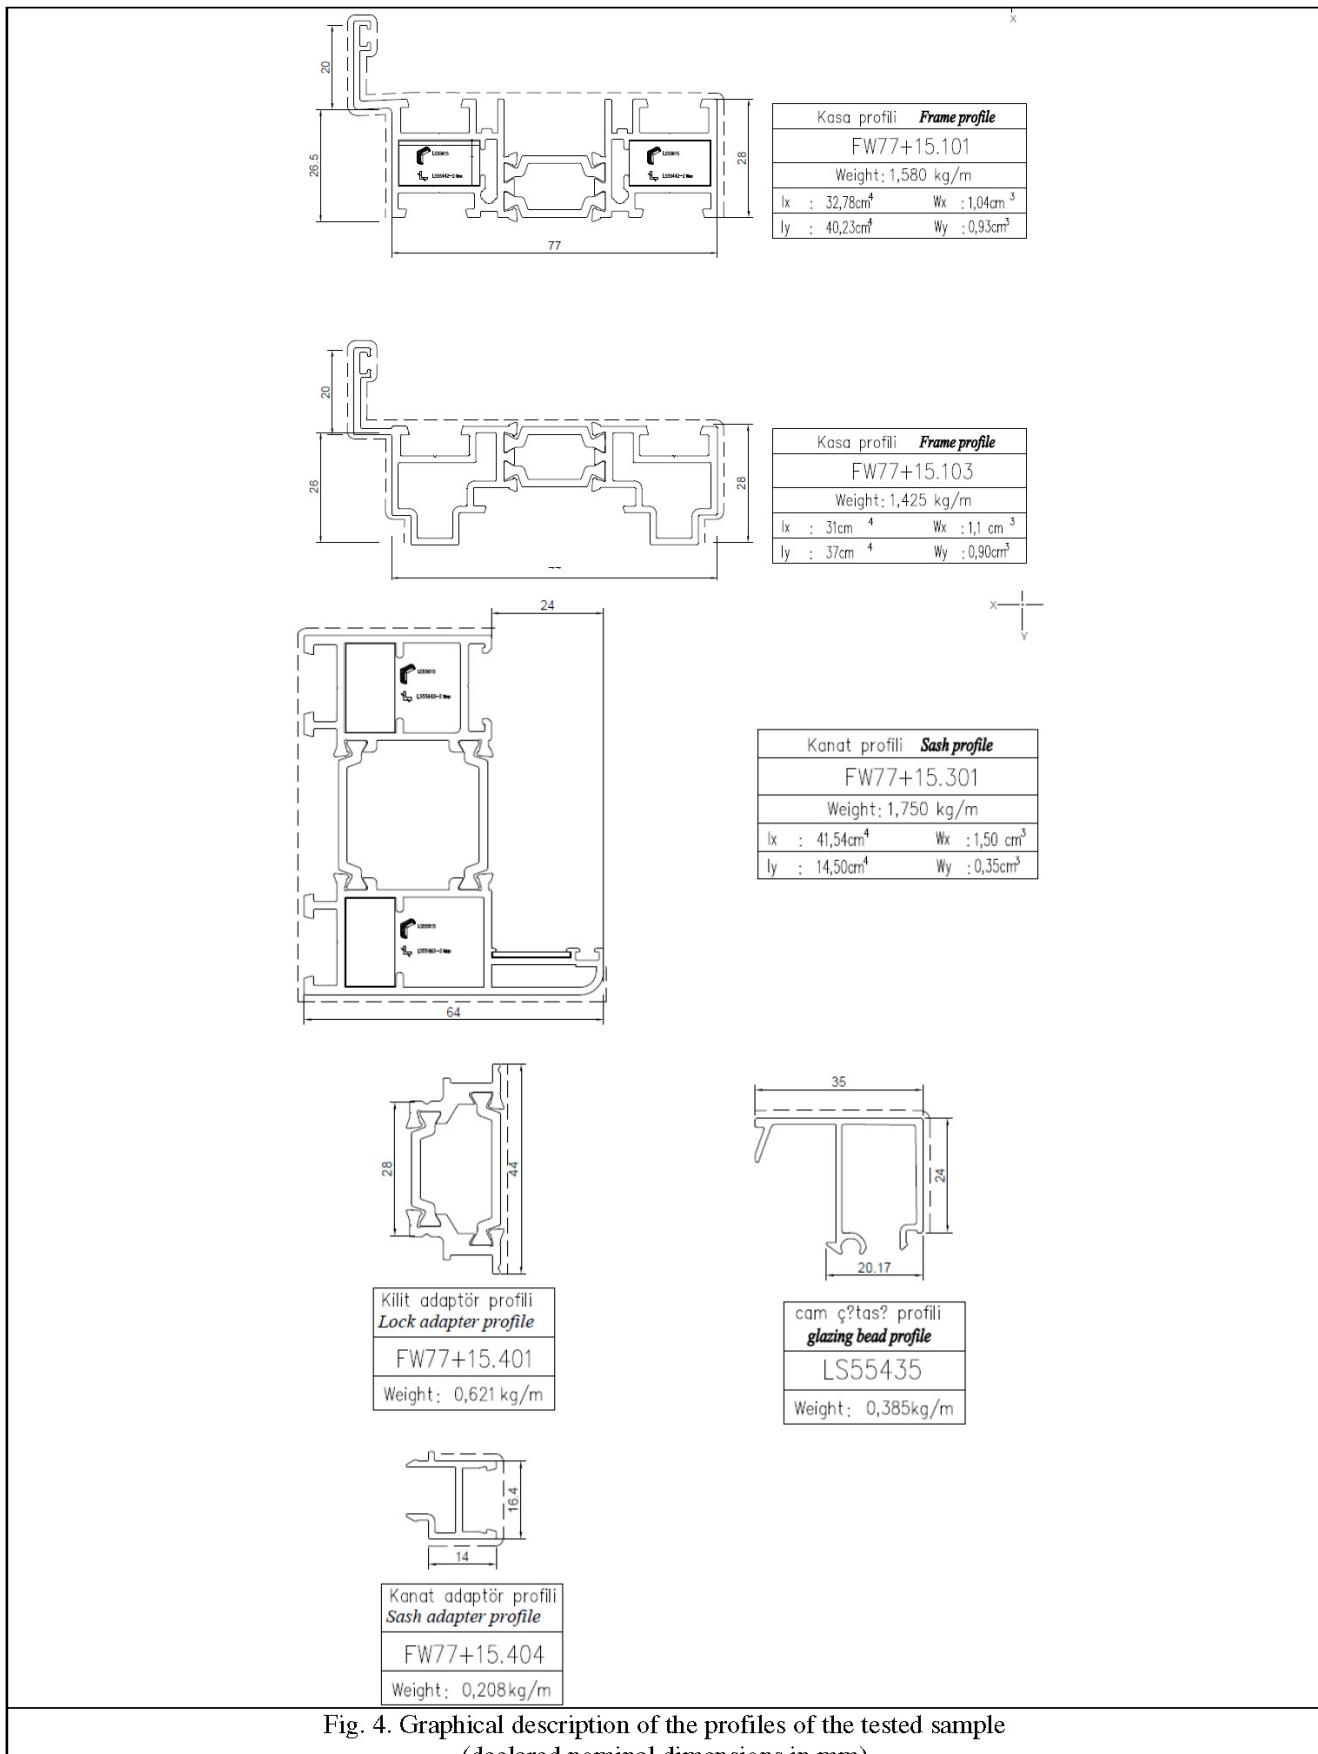
Fig. 4. Graphical description of the profiles of the tested sample
(declared nominal dimensions in mm)

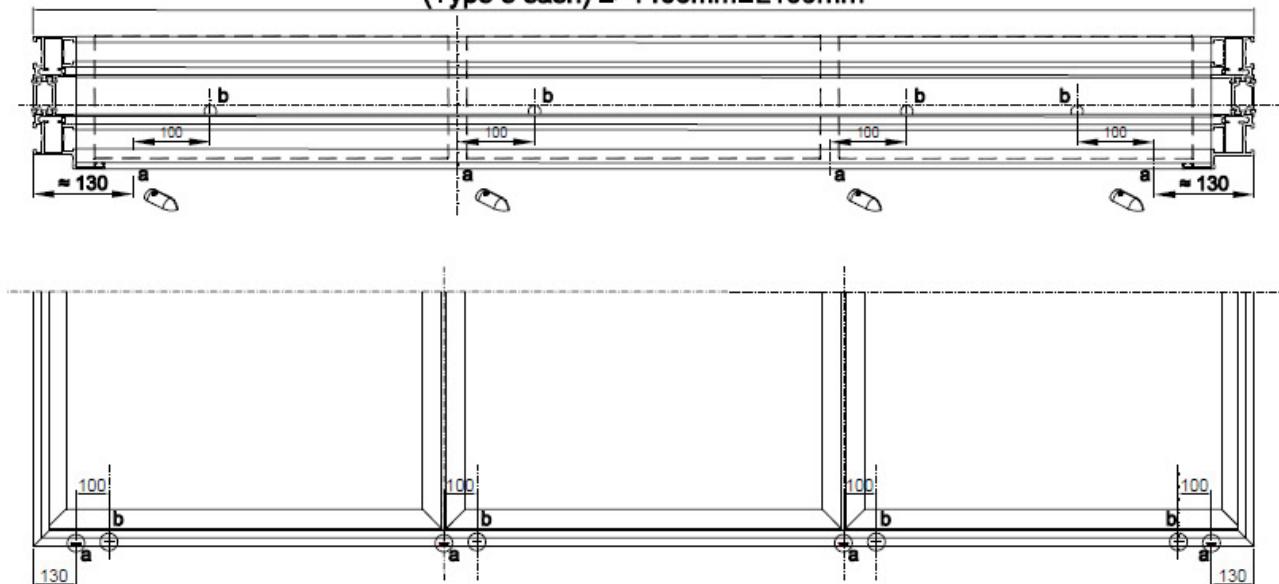
Fig. 6. Graphical description of the discharge slots of the tested sample
(declared nominal dimensions in mm)

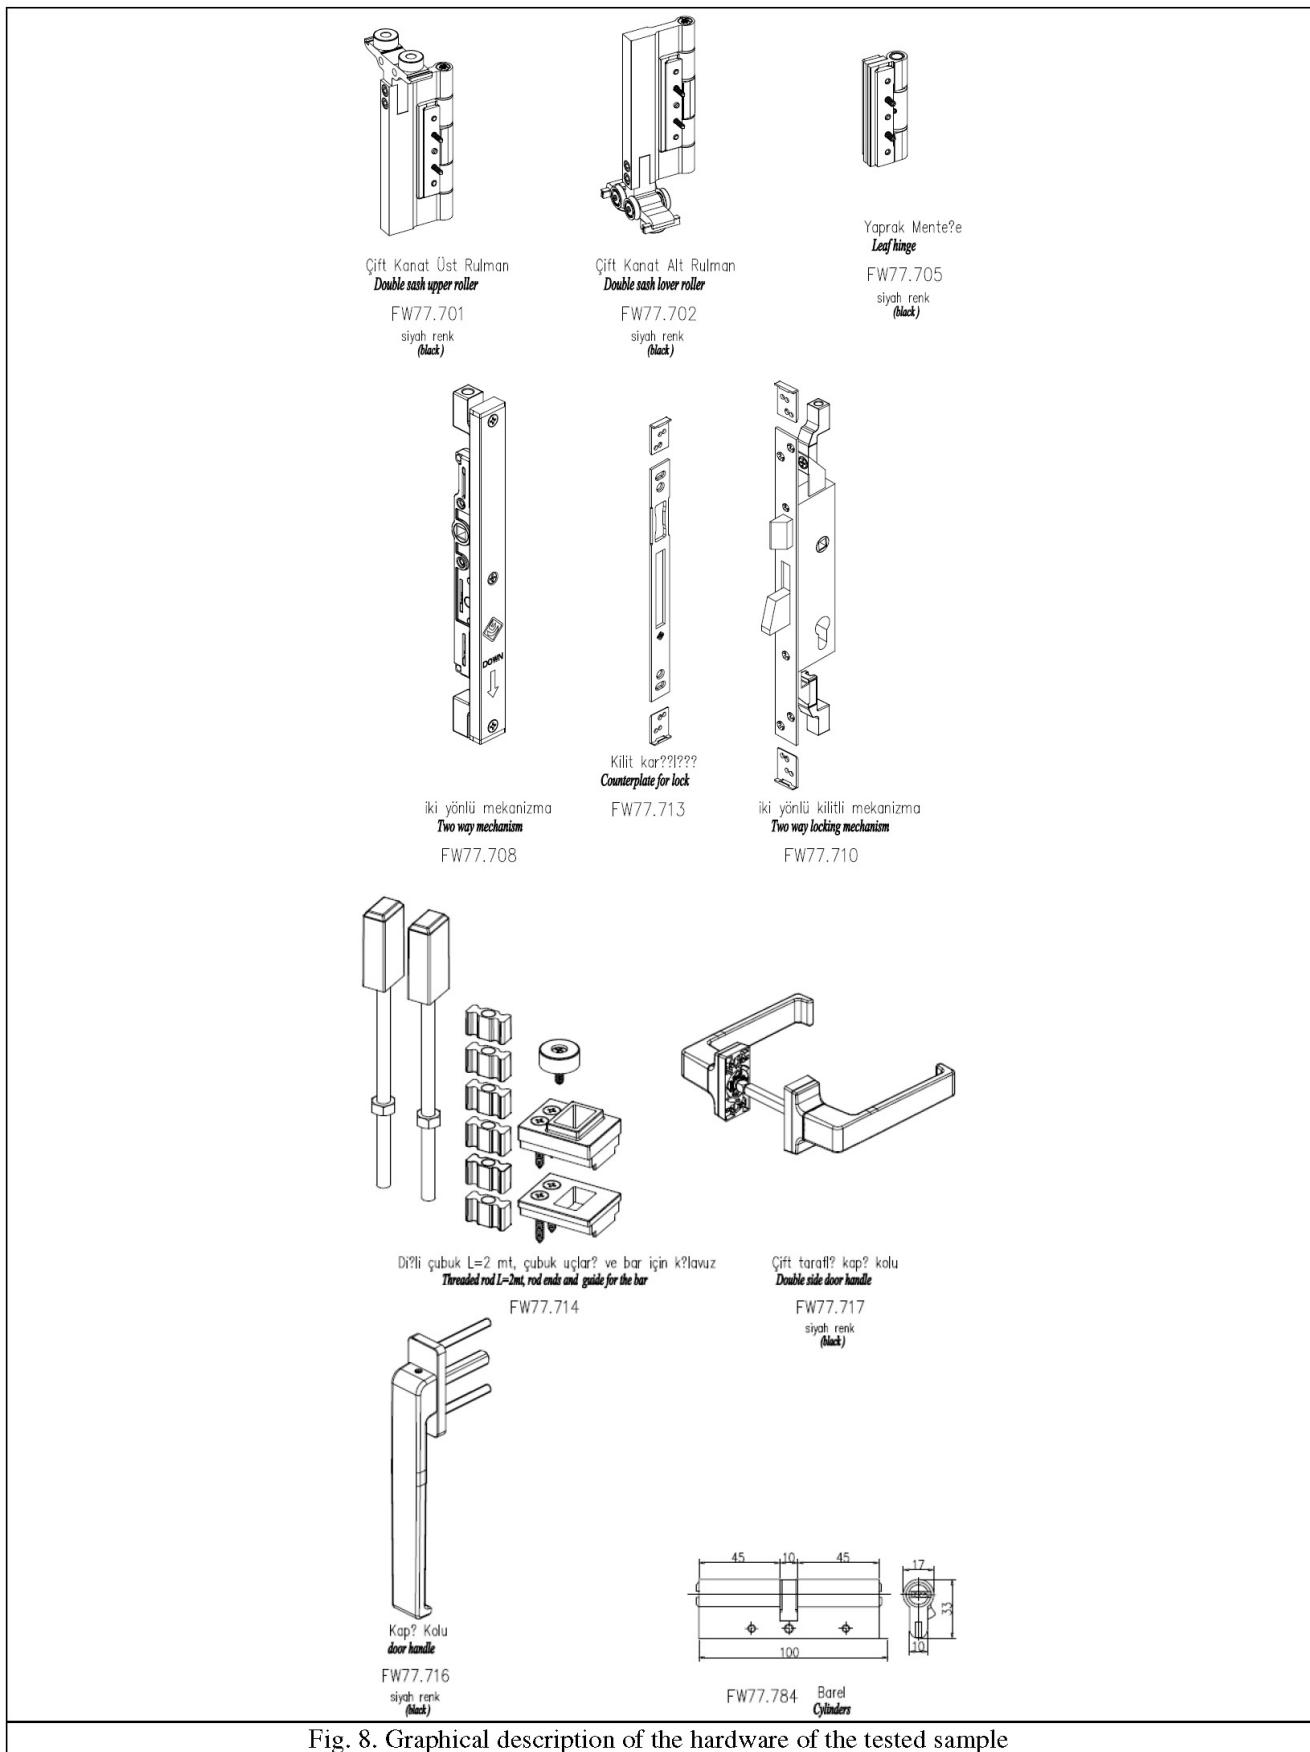
Fig. 8. Graphical description of the hardware of the tested sample
(declared nominal dimensions in mm)

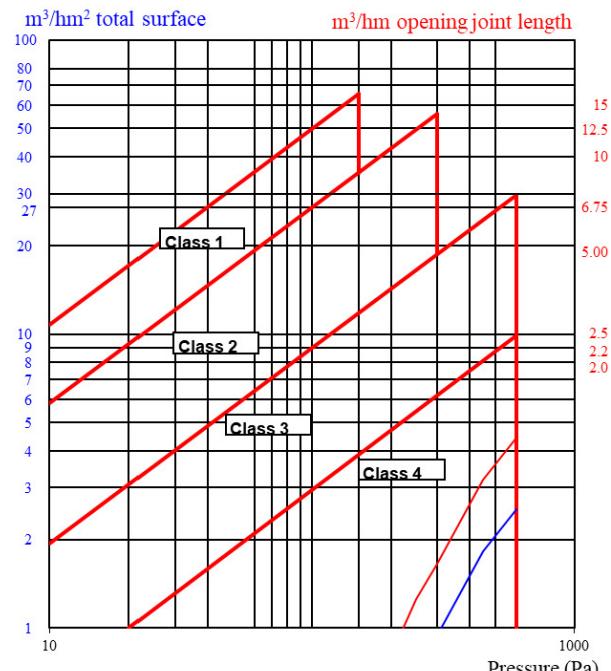
Diagram 1

The sample subjected to air permeability test under positive and negative pressures was classified in class 4 with reference to the standard EN 12207:1999.

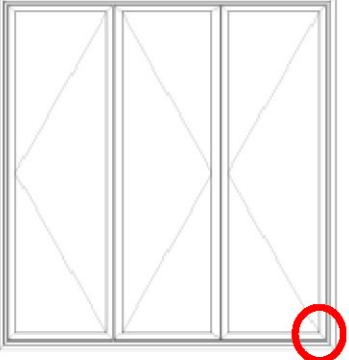
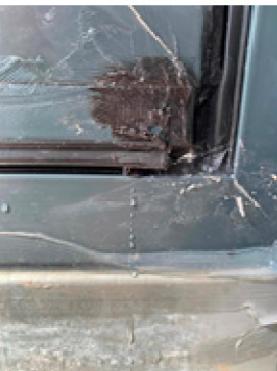
| Pressure (Pa) | Duration (min) | Remarks |
|---|---|--|
| 450 | 1'00'' | Infiltration at the bottom of the sash |

The sample subjected to watertightness test was classified in **class 7A** with reference to the standard EN 12208:1999.

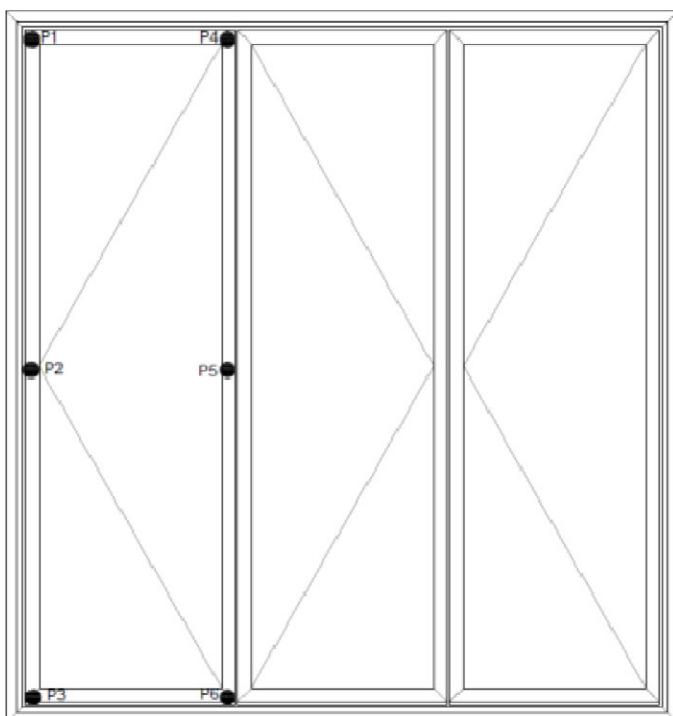
Legend:
1, 2, 3 Lateral Mullion
4, 5, 6 Central Mullion

Fig. 9. Experimental set-up wind load test internal view:
transducers positioning scheme - placed on the inner side

At the end of the deformation test, no visible defect was observed during a check carried out by normal and corrected visual observation at 1 m, and the sample remained in a satisfactory condition. The relative frontal deflection of the most deformed element of the tested sample is < 1/300 for 800 Pa and < 1/200 for 1200 Pa.

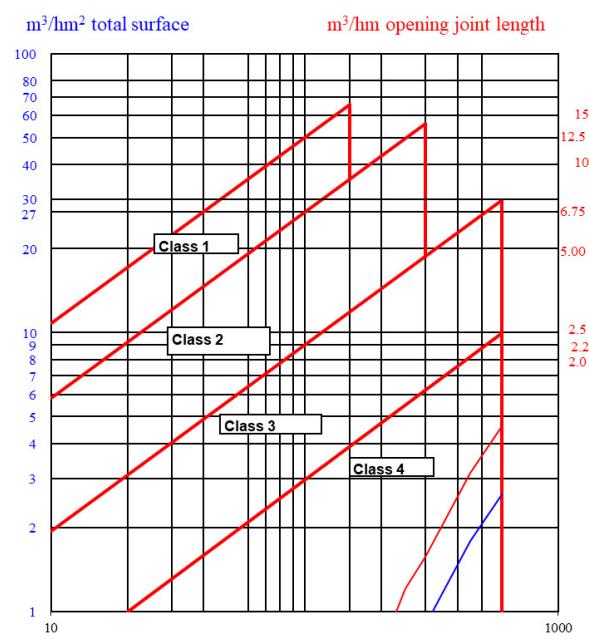
Diagram 2

The requirement to limit the maximum increase detected in air permeability to within 20% of the maximum allowable air permeability for the class previously obtained is achieved.

The sample tested for air permeability after the wind load resistance test confirmed the class previously achieved.

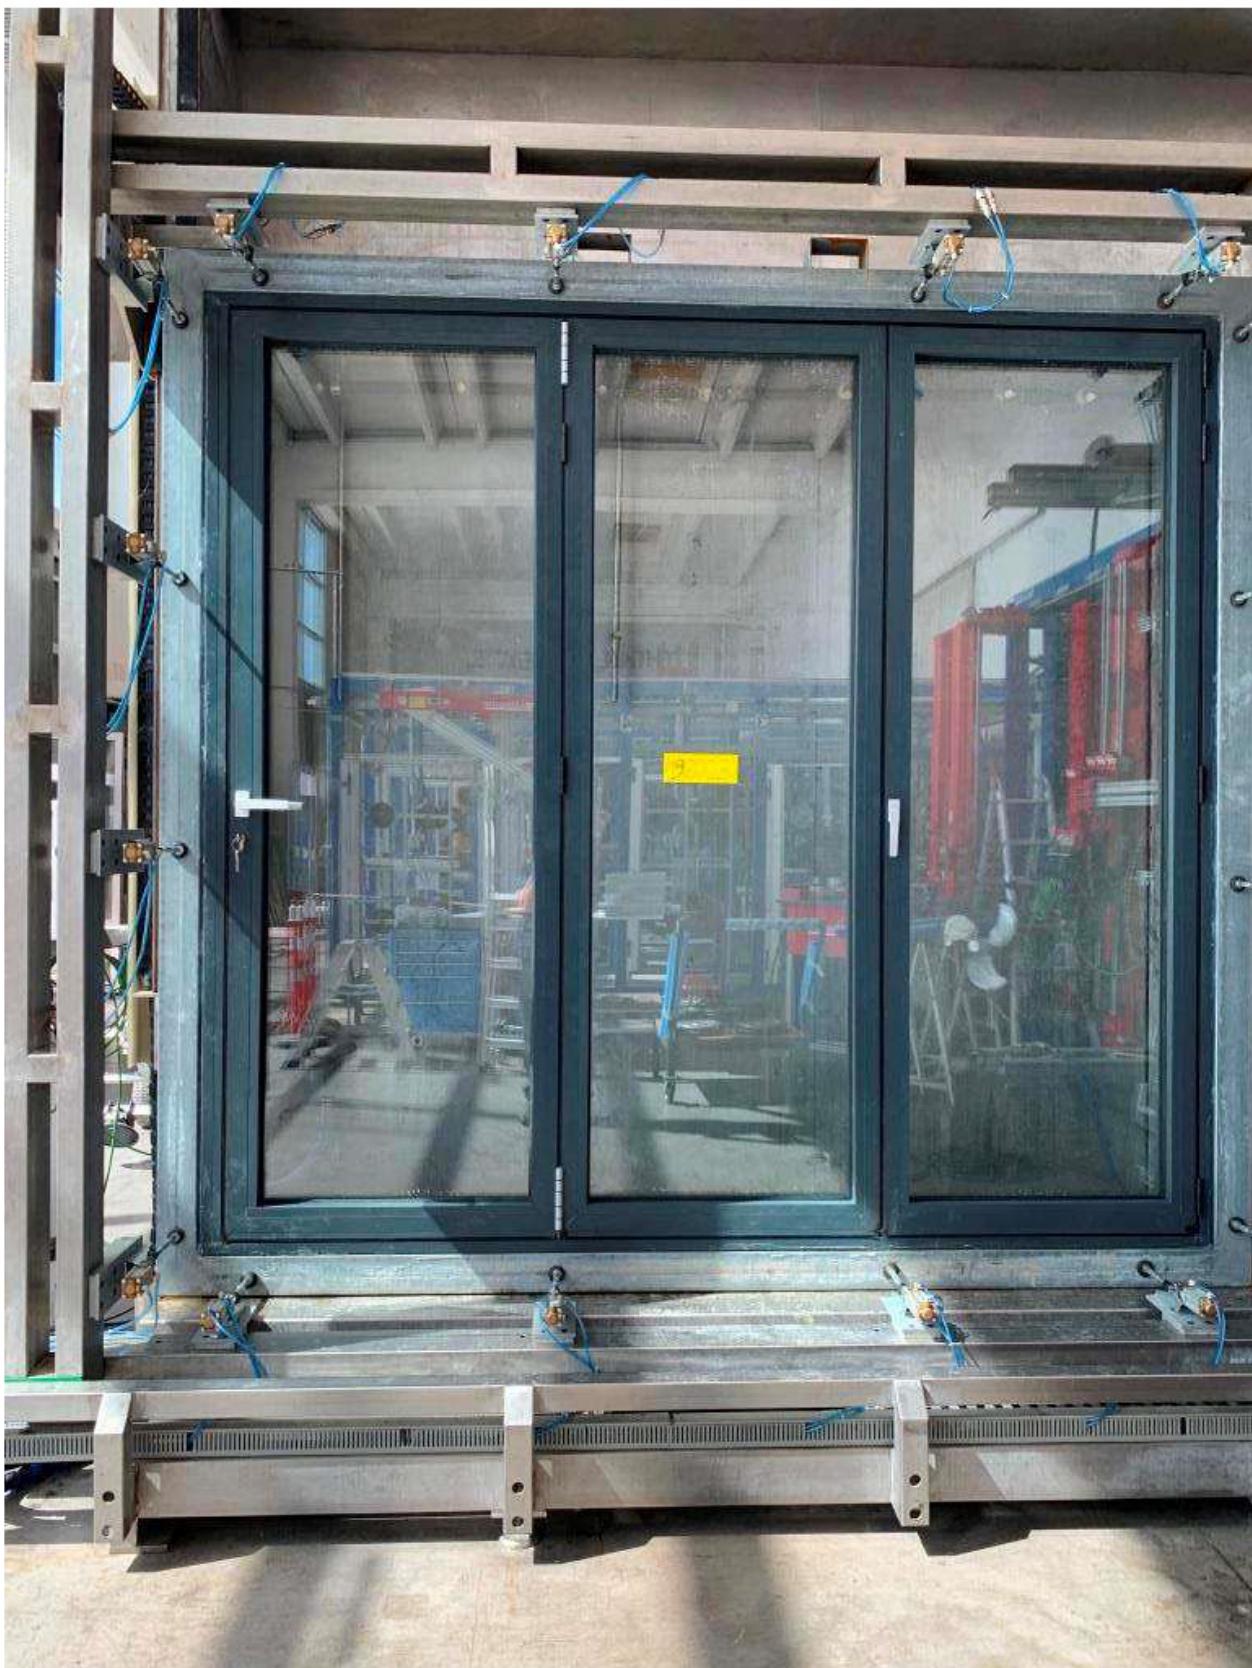
Photo 1: Tested sample in the experimental setup

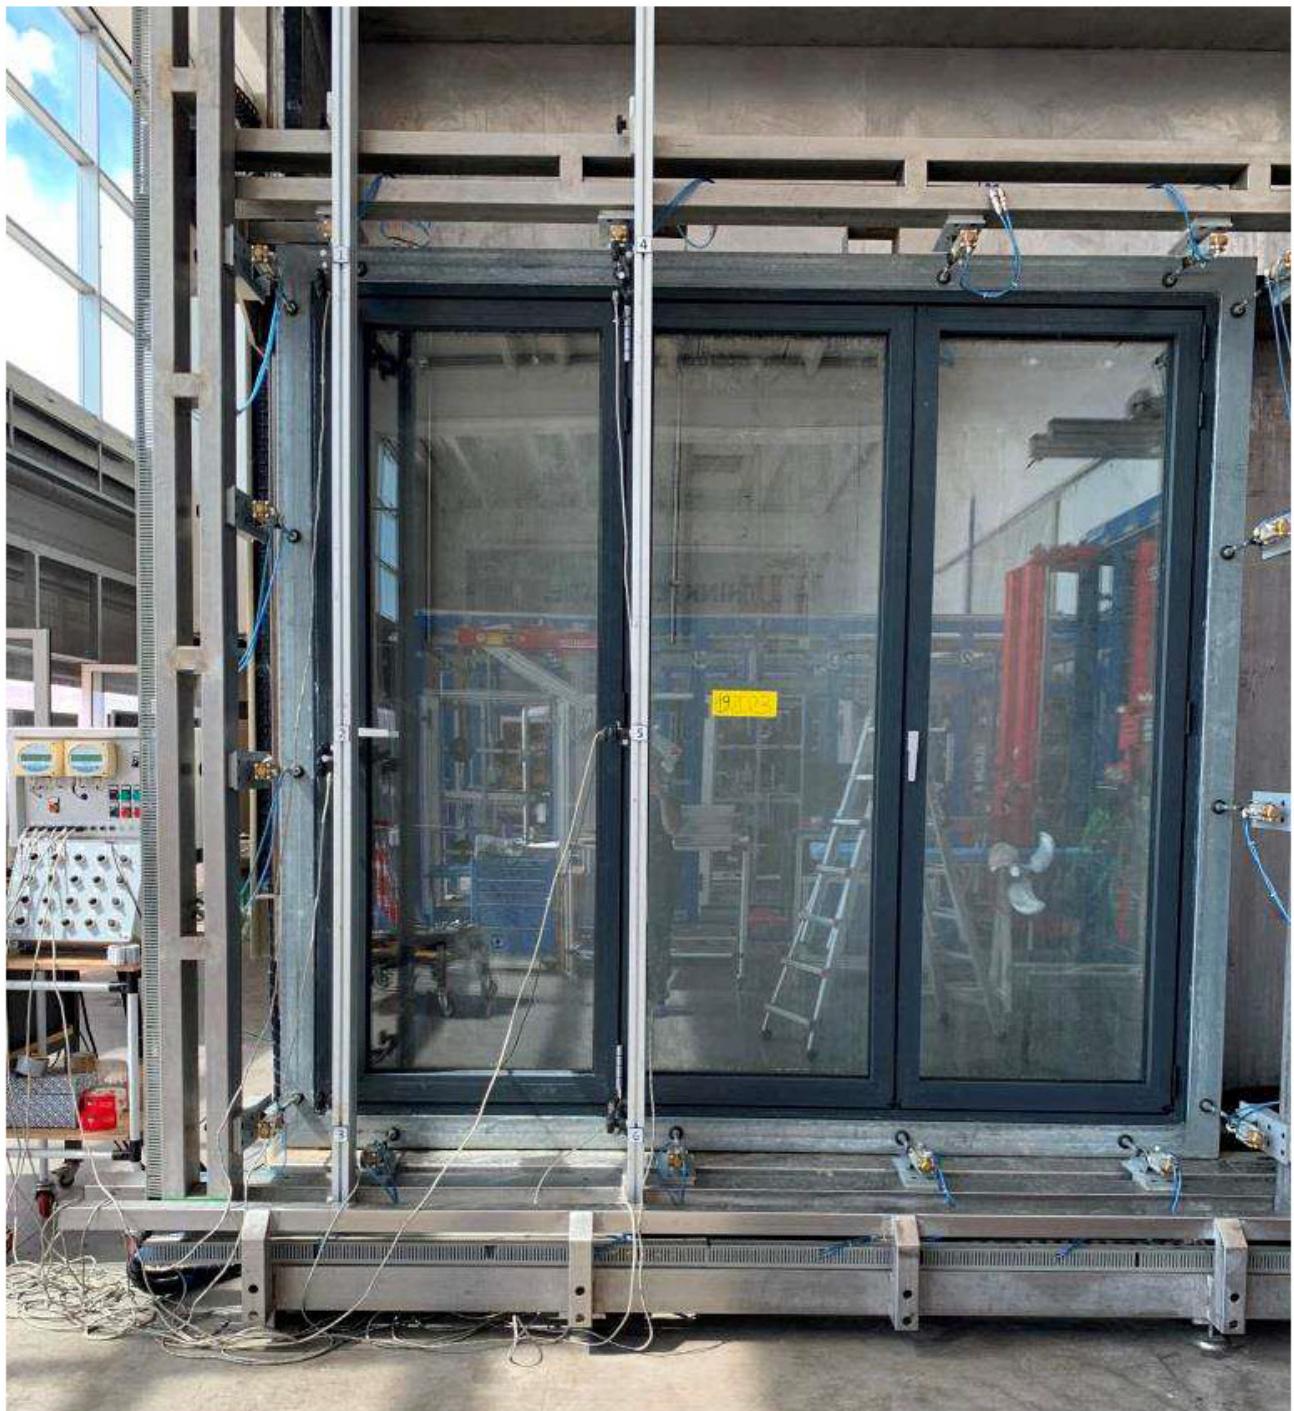
Photo 2: Sample under wind load tests
